LOUISIANA DEPARTMENT OF WILDLIFE & FISHERIES

WATERBODY MANAGEMENT PLAN SERIES

IATT LAKE

LAKE HISTORY & MANAGEMENT ISSUES

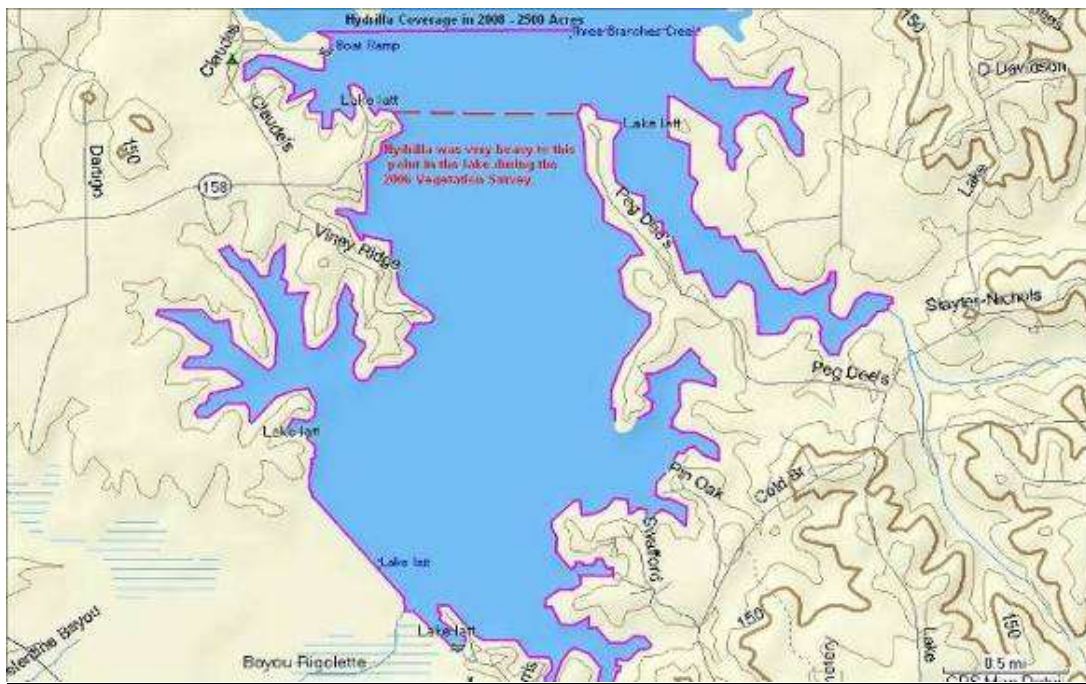
Figure 2. Hydrilla Coverage – Approximately 2500 Acres Prior to Summer 2008 Drawdown.

Hydrilla was discovered in the fall of 1996. This submerged invasive plant soon displaced native vegetation in the lower third of the lake. A summer/fall drawdown initiated in 2008 was followed by extensive hurricane-induced high water levels. Hydrilla coverage was reduced in the lower third of the impoundment as a result. In February 2009, Iatt Lake was stocked with 21,300 triploid grass carp. Since that time, vegetation monitoring has found no hydrilla regrowth in the lake.

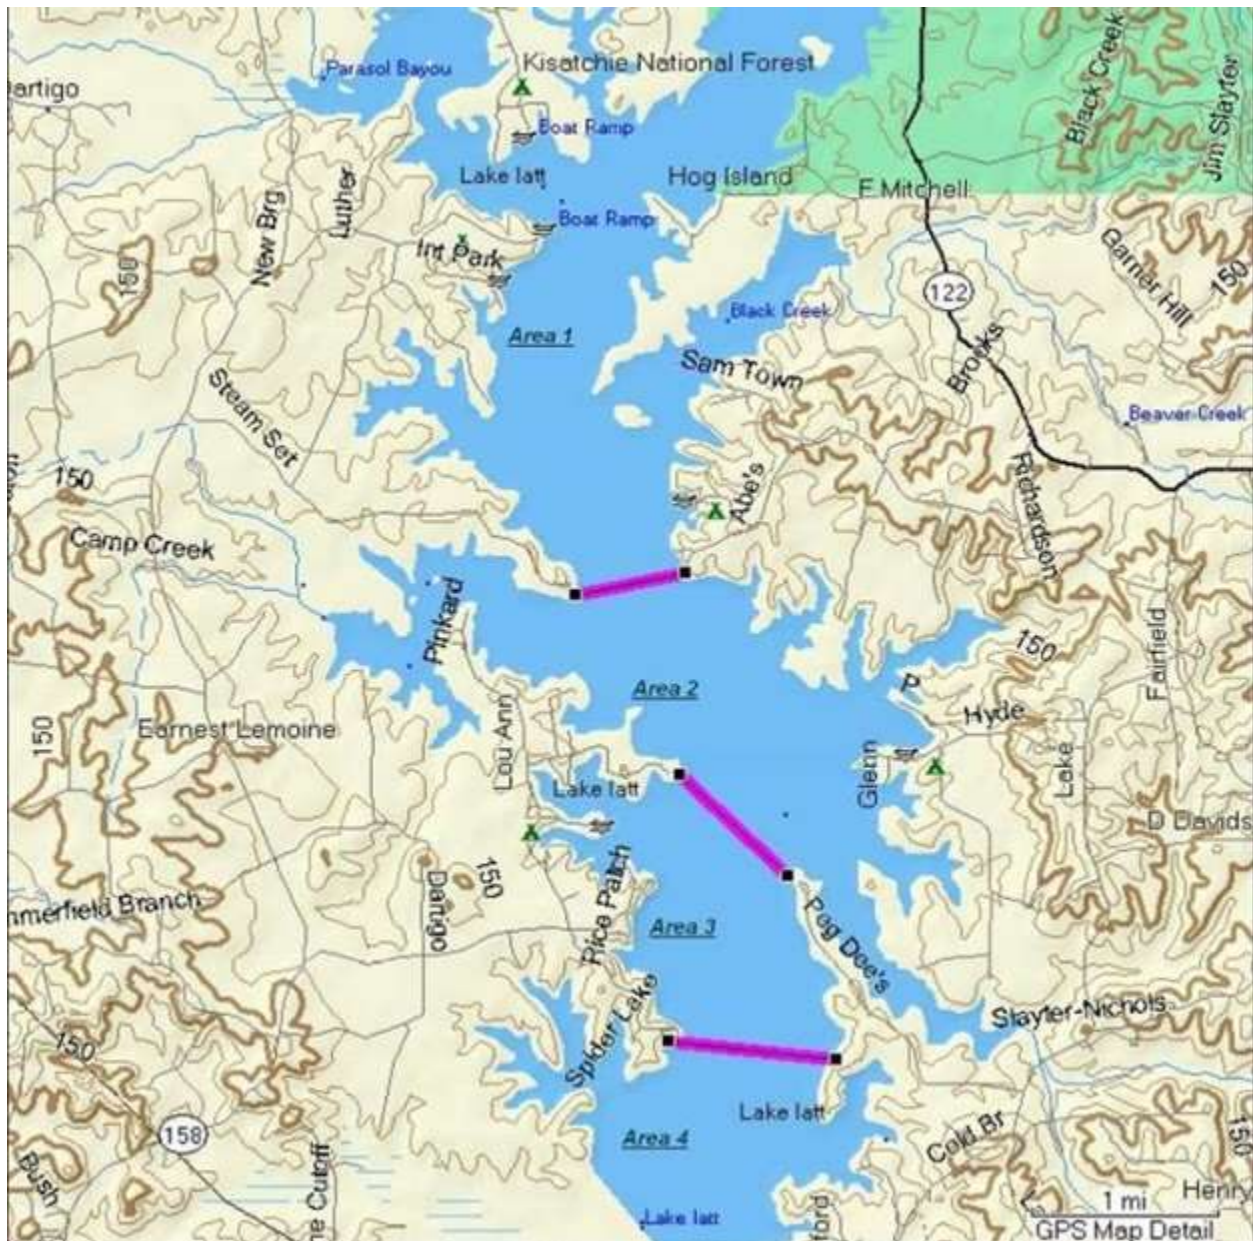
**Iatt Lake
Vegetation Type map
June and August 2013**

As in past years, the majority of the lake was infested with vegetation. Greater than 80% of the lake area was infested with submersed vegetation primarily fanwort and bladderwort. Additional submersed vegetation included coontail, southern naiad, and filamentous algae. The only area of the lake without submersed vegetation was the deep water channels. Unlike recent years no hydrilla was observed. Triploid grass carp stocked in 2009 have apparently alleviated hydrilla, at the current time.

Emergent vegetation was found throughout the lake. The dominant emergent vegetation observed was American lotus. Numerous additional species observed included water hyacinth, white water lily, pennywort, alligatorweed, common and giant salvinia, and duckweed to name a few.

Area 1 – 75 % American lotus, 30% water hyacinth, scattered common and giant salvinia, fringe of alligator weed and pennywort

Area 2 – 40% American lotus, 40% water hyacinth, mixed with white water lily, scattered common and giant salvinia, fringe of alligator weed and pennywort
